Applicability of Photogrammetry for Inspection and Monitoring of Dry-Stone Masonry Retaining Walls

TRB 99th Annual Meeting
January 14, 2020 | Washington, DC

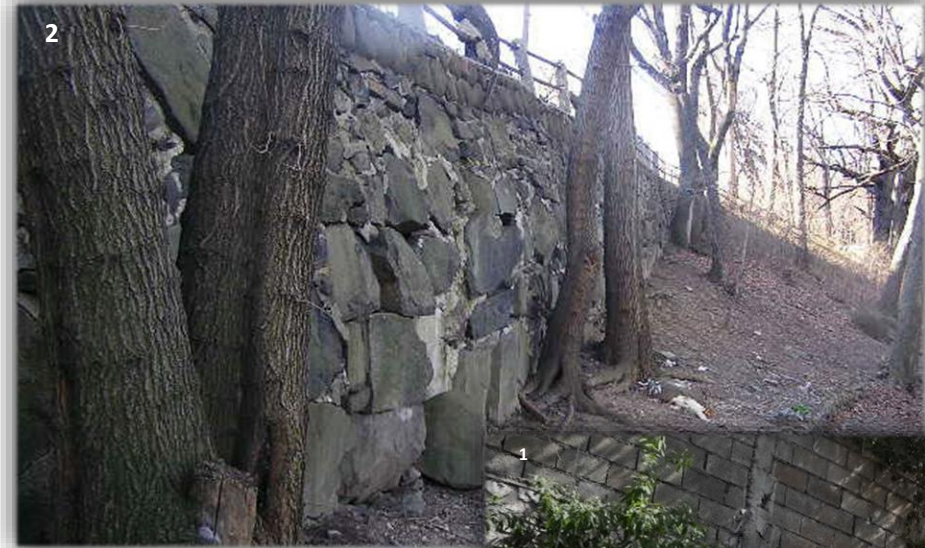
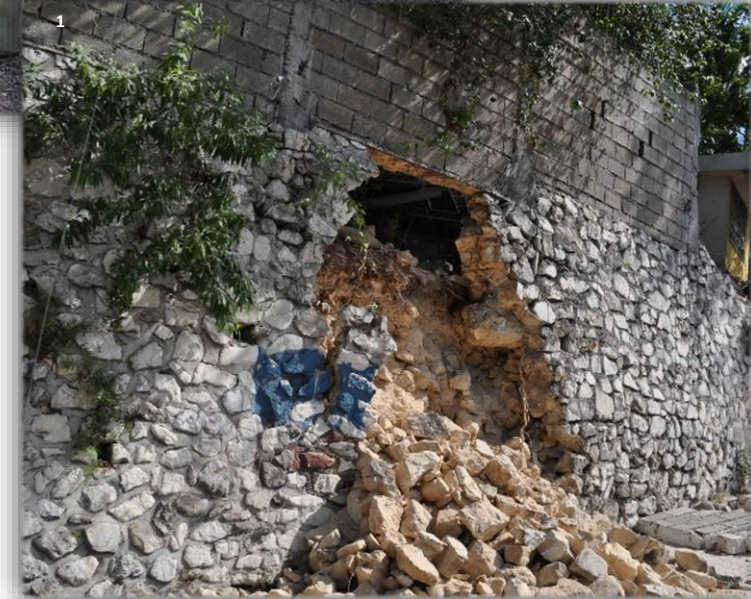
- Dry-stone masonry retaining walls are built by interlocking stones without mortar.
- Lack of cohesion allows for internal deformation and sliding between the stacking planes.
 - Prone to bulging and leaning
- Assessed by visual inspections and traditional surveying tools.
- The unpredictable behavior of this type of wall can lead to maintenance problems and need for monitoring

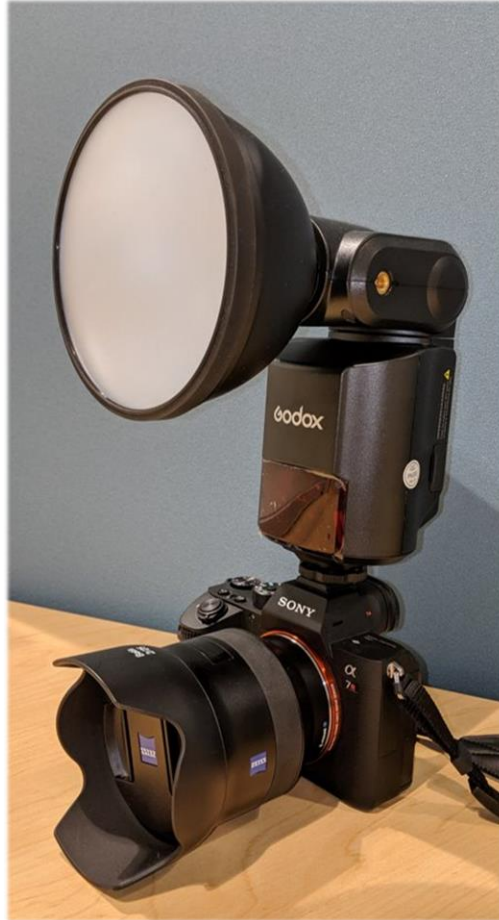
- Sony a7RIII (42-megapixel 25-mm full-frame sensor)
- Low-distortion Zeiss Batis 2/25
- Godox flash

RealityCapture software was used for model generation

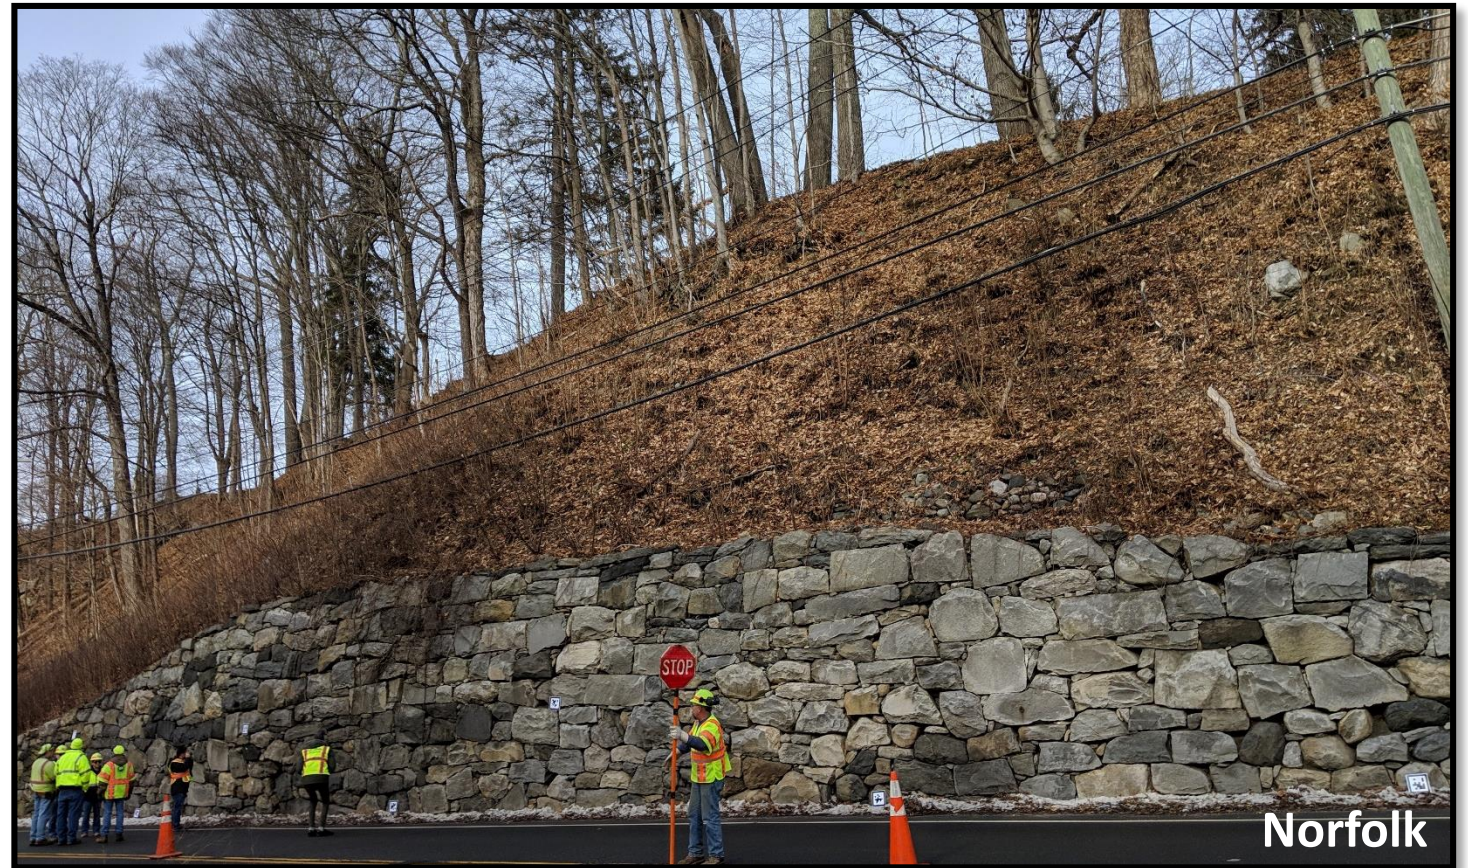
Focus: Determine if the wall was actively bulging following heavy rain.

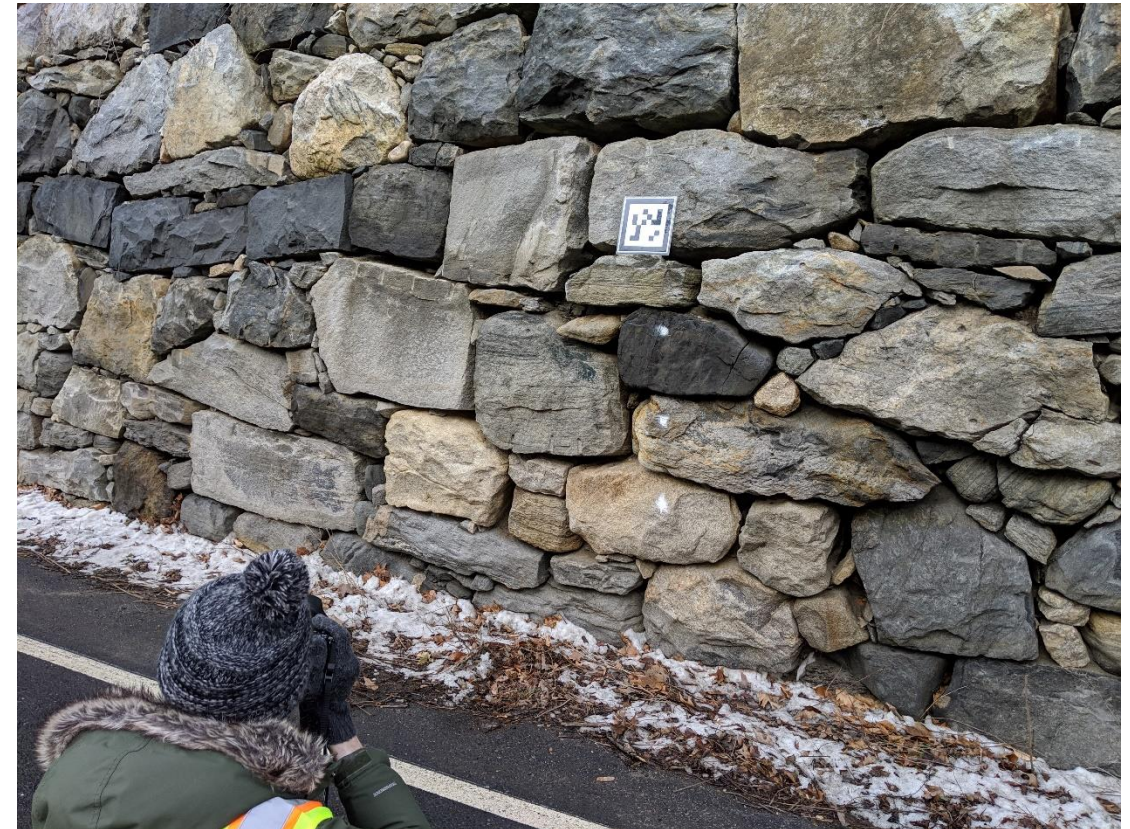
- Data collection took ~1 hour with ~850 images collected
- The final models:
 - Represented an area of ~150 m² (1,615 ft²)
 - Consisted of >4 million vertices
 - Exported to a ~1 GB mesh

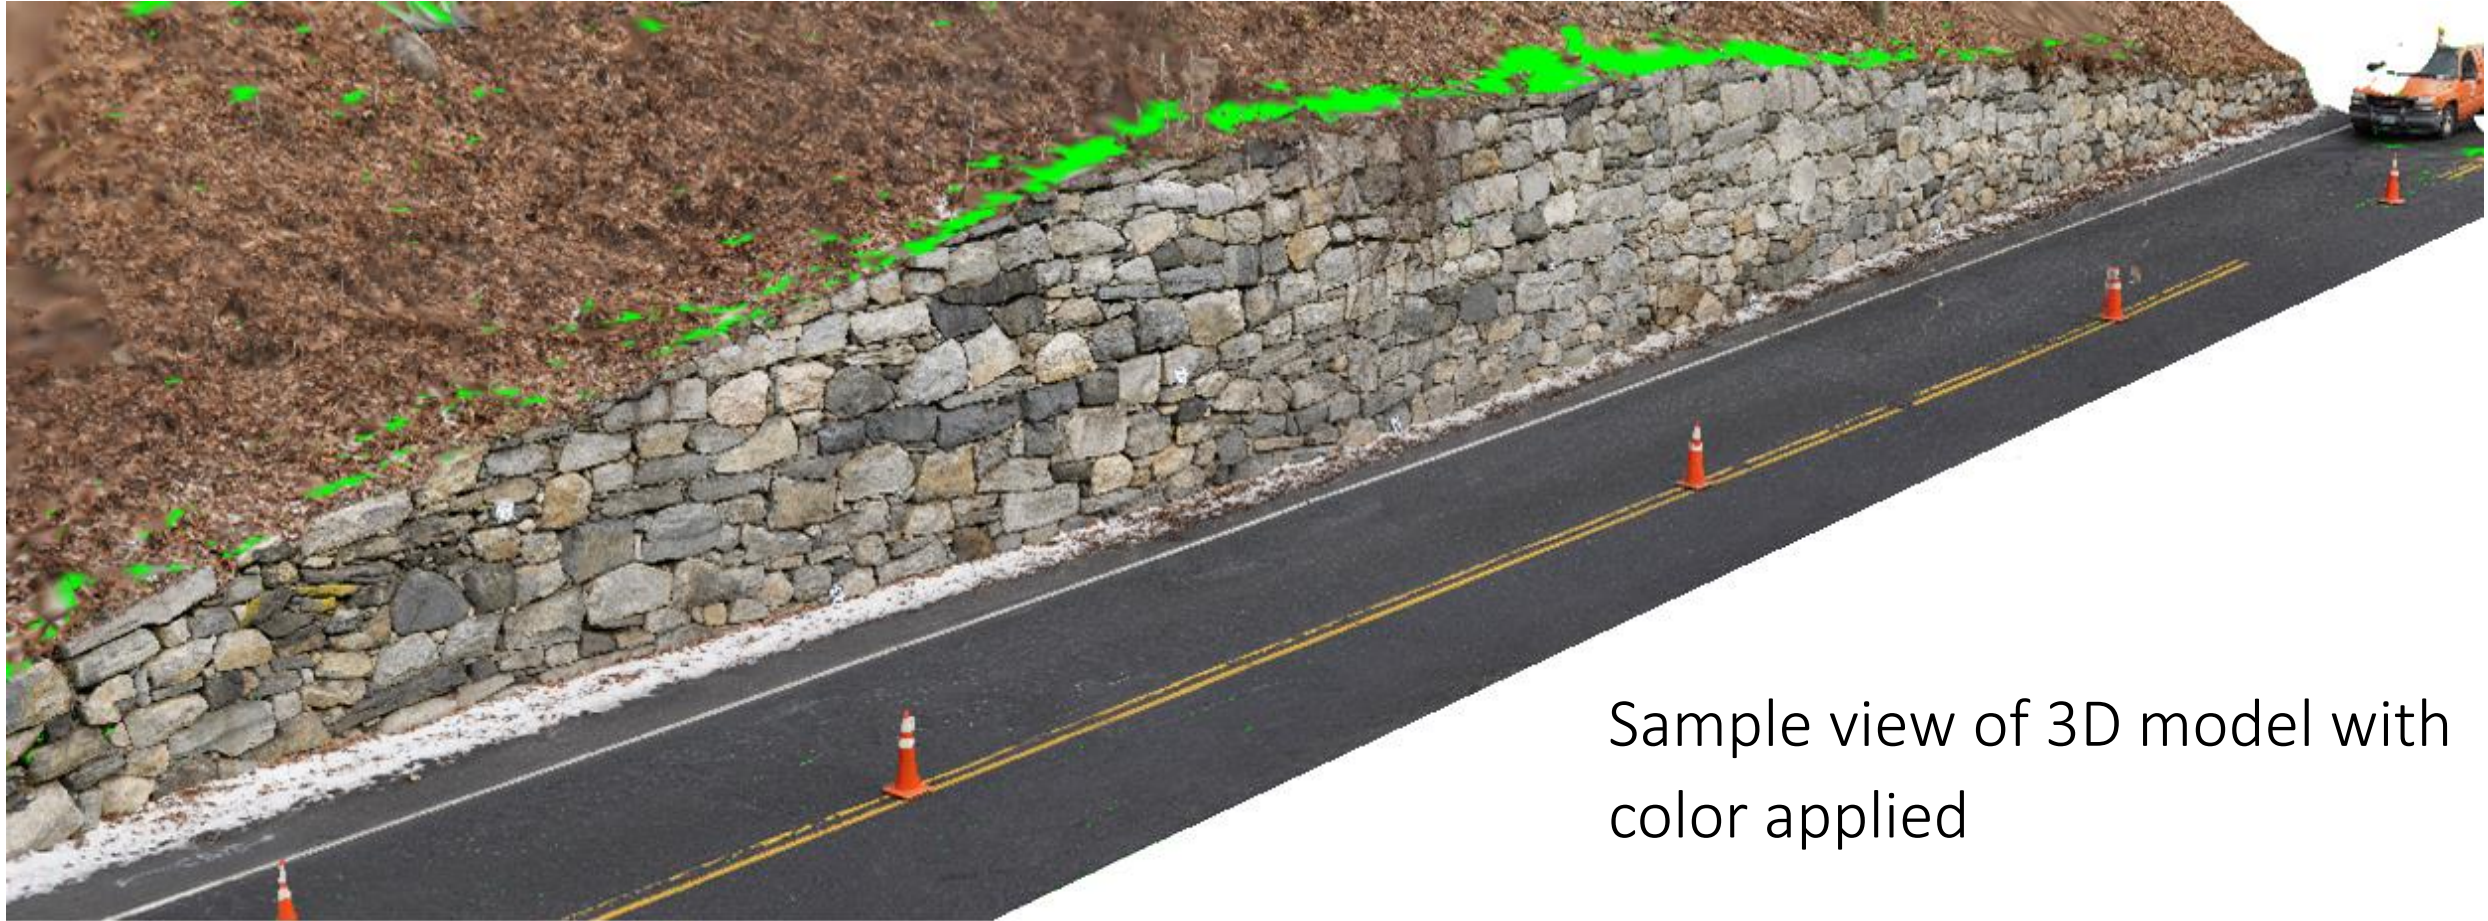
Sample view of 3D model with color applied

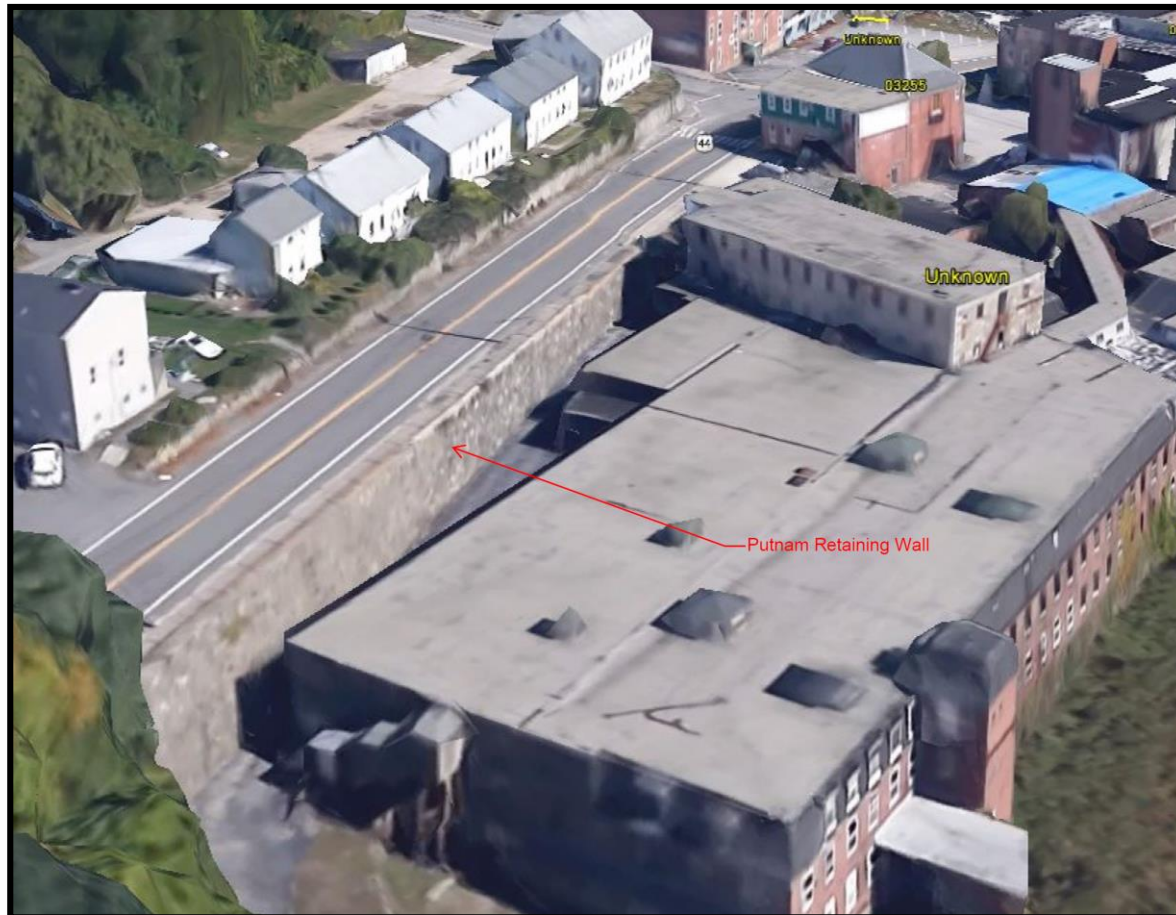
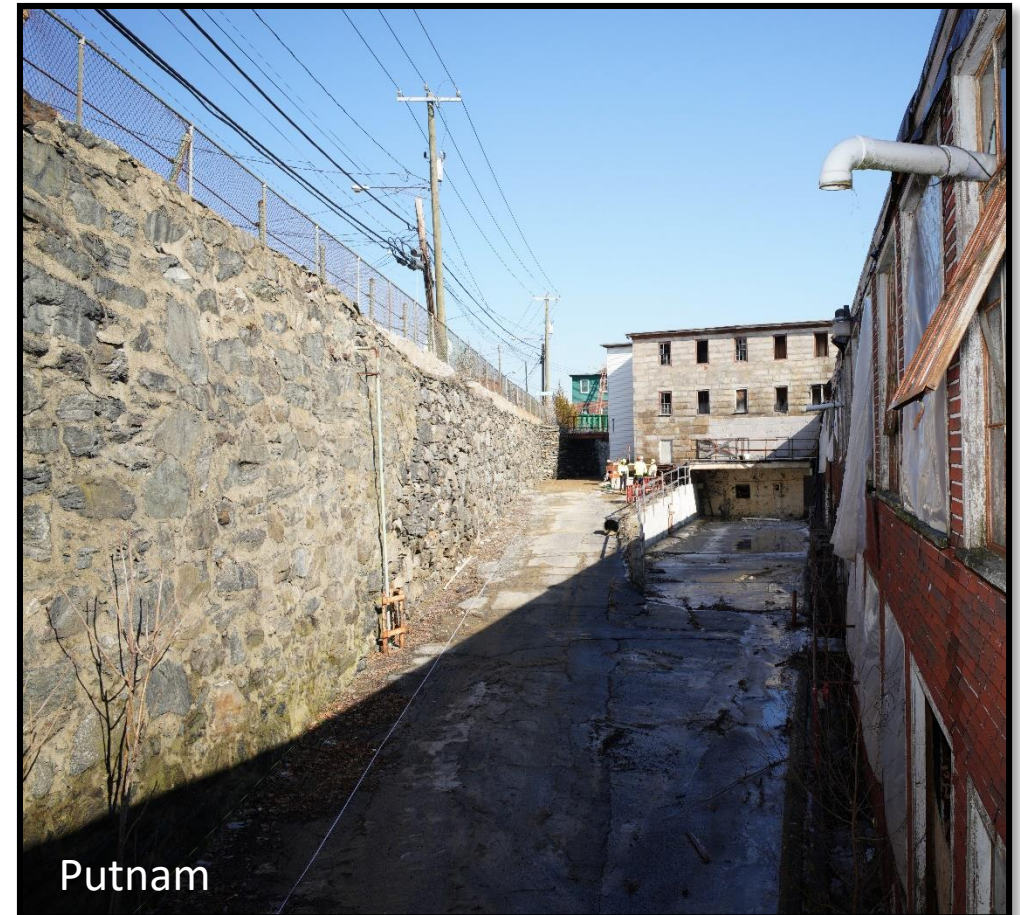
Focus: Obtain condition of retaining wall following fire hydrant burst.

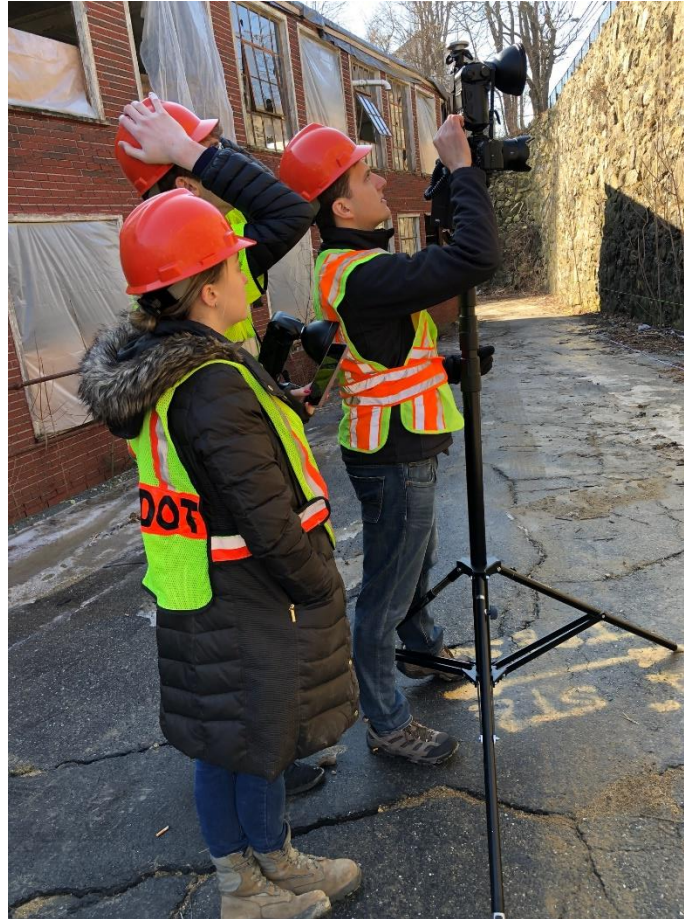
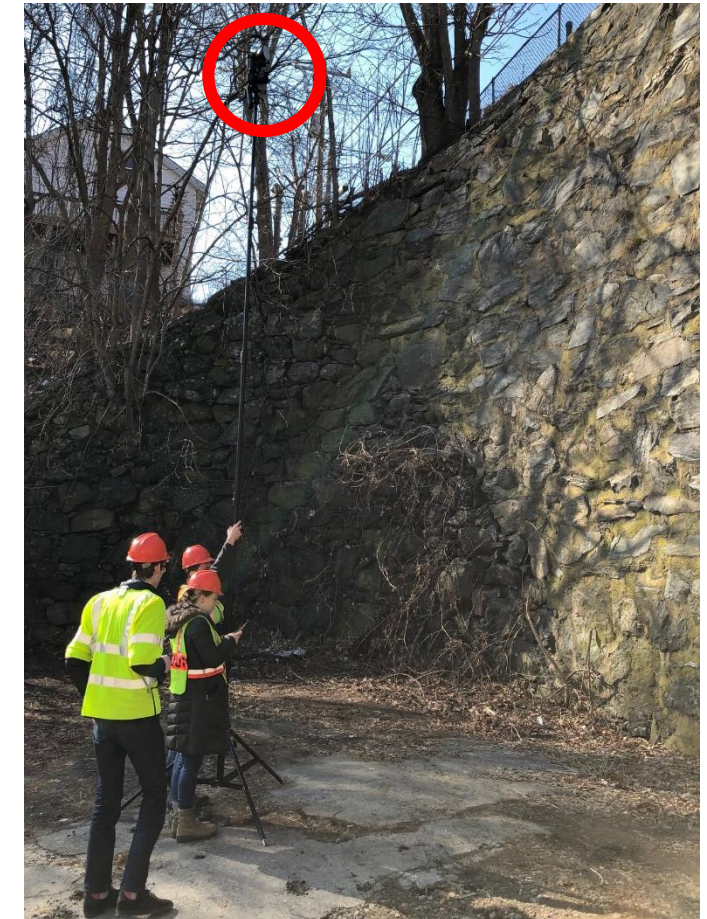
- Data collection took ~2 hours with ~1,250 images collected
- The final models:
 - Represented an area of ~600 m² (6,500 ft²)
 - Consisted of ~30 million vertices
 - Exported to a ~5 GB mesh
