# MDT Rockfall Hazard Assessment

## Rock Slope Asset Management Program RAMP

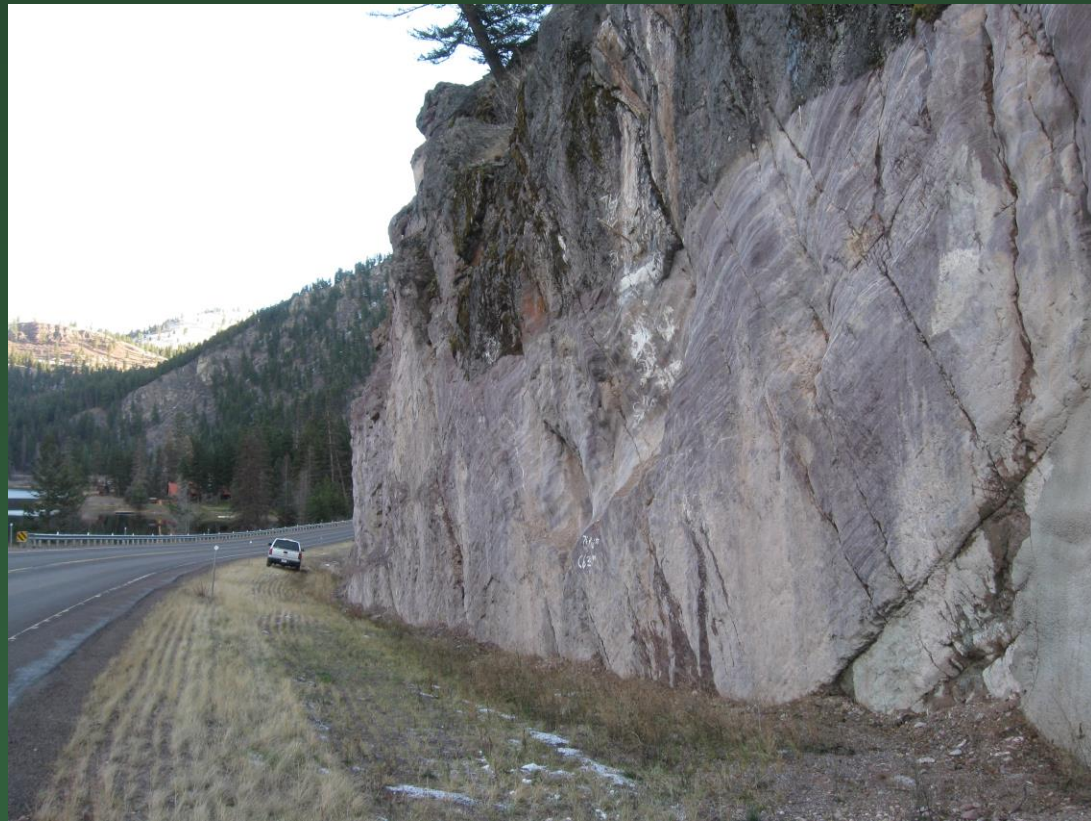
Good (CS1)

G/F/P Descriptor	Condition State	Cond. Index Range	Description
Good	1	100 - 80	Rock slope produces little to no rockfall and no history of rock reaching the road. Little to no maintenance needs are performed due to rockfall activity. All mitigation measures, if present, are in new or like-new condition.
Fair	2	80 - 60	Rock slope produces little to no rockfall that may rarely reach the road. Some maintenance needs to be performed due to rockfall activity. Mitigation measures, if present, are in good condition, with only surface wear.
Fair	3	60 - 40	Rock slope produces occasional rockfalls with rock occasional contact with the road. Maintenance is required bi-annually to maintain safety. Mitigation measures, if present, appear to have some effectiveness. Some minor damage to minor elements of road. Maintenance or replacement of minor mitigation measures is warranted.
Poor	4	40 - 20	Rock slope produces frequent rockfall with rocks frequently reaching the road. Maintenance is required annually to maintain ditch performance. Mitigation measures, if present, appear to be ineffective due to significant damage to minor elements of road. Maintenance or replacement of minor mitigation measures is warranted.

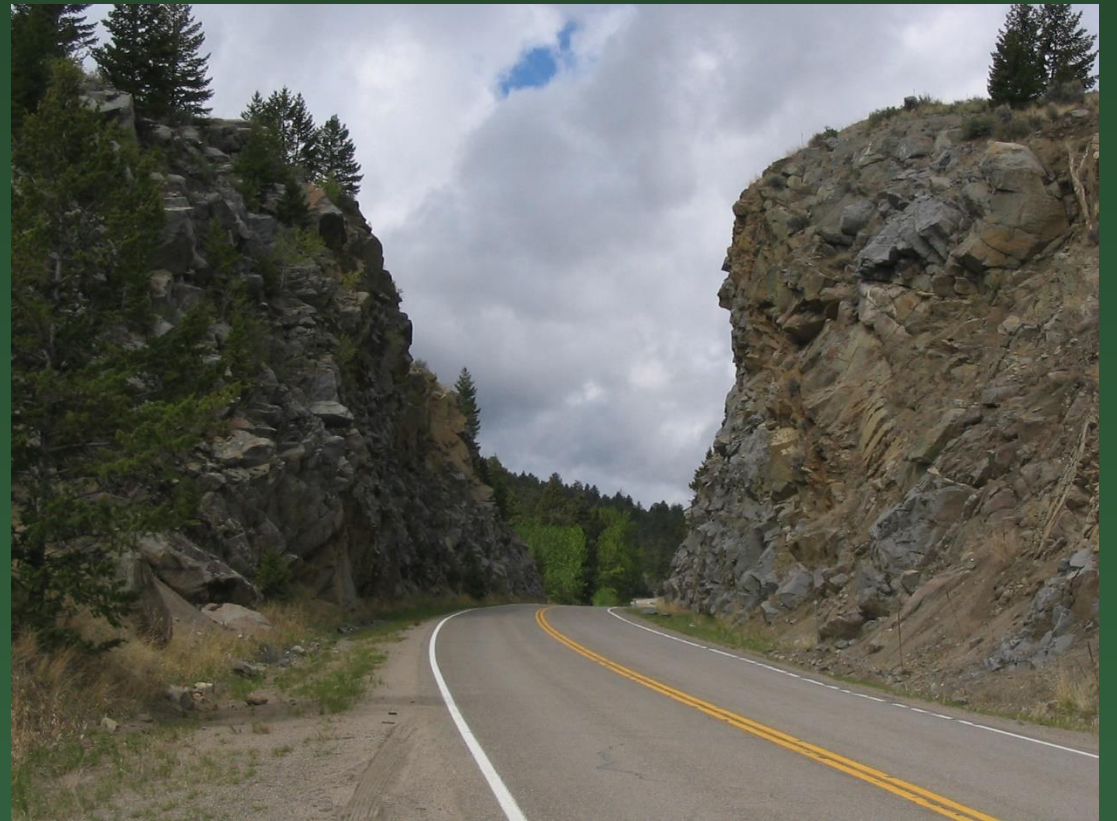
Poor (CS5)

Poor	5	20 - 0	Rock slope produces frequent rockfall and nearly all rocks reach the road. Virtually no rockfall catchment exists. Maintenance must respond to rockfall regularly, possibly daily during adverse weather conditions. Mitigation measures, if present, are nearly all ineffective either due to deferred maintenance, significant damage, or obvious deep corrosion.

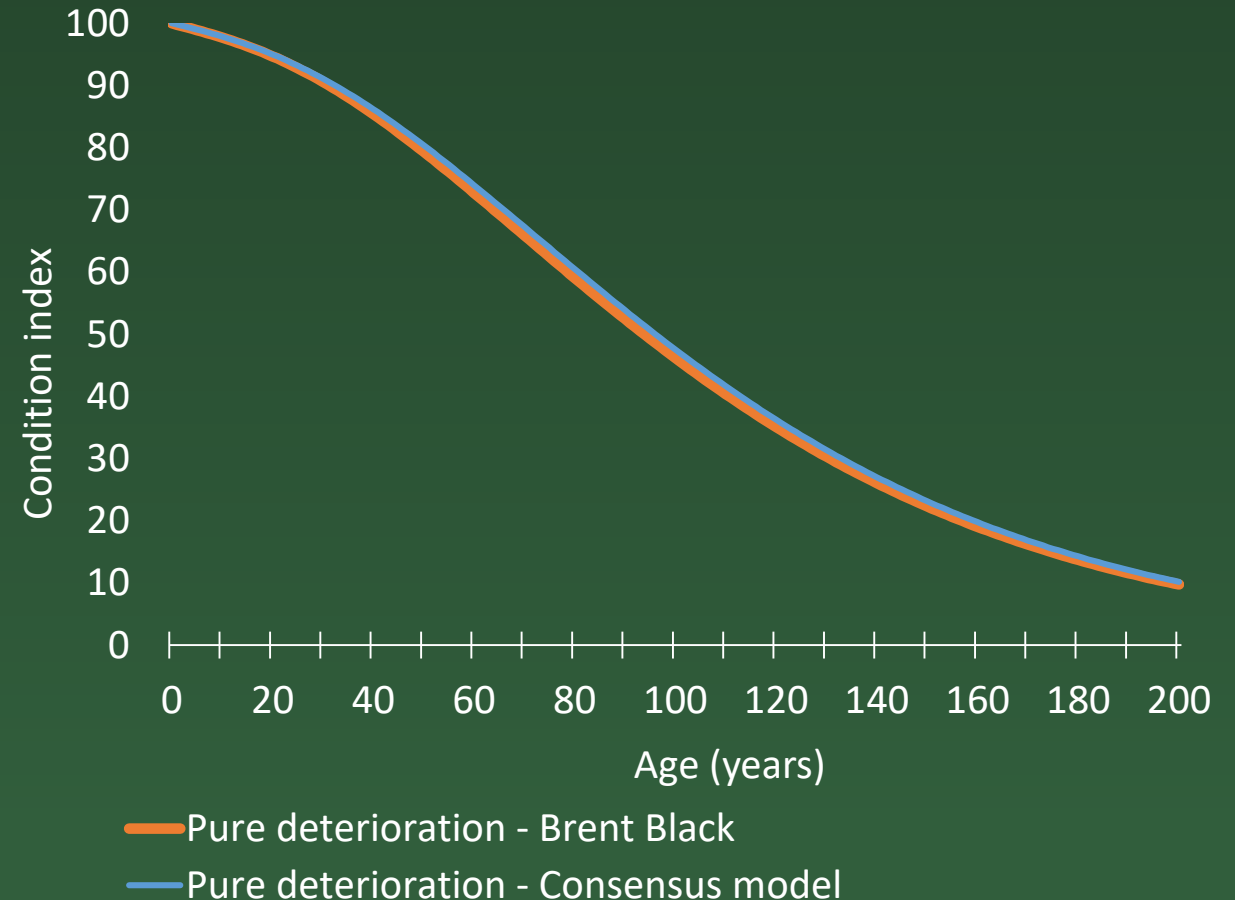
# Slope Deterioration Rates

- Expert Elicitation
- Nearly all MDT Geotechnical Personnel Participated and MDT's rock slope mitigation design personnel

*Imagine there are 100 assets in the indicated Condition State. After how many years will 50 of them have deteriorated to the next Condition State or worse, if no maintenance or corrective action is taken?*
